CAMPAIGN BULLETIN

Subject: **Safety Recall 08C4**
Sterling 360 Turbocharger Bracket

Safety Recall Bulletin 08C4

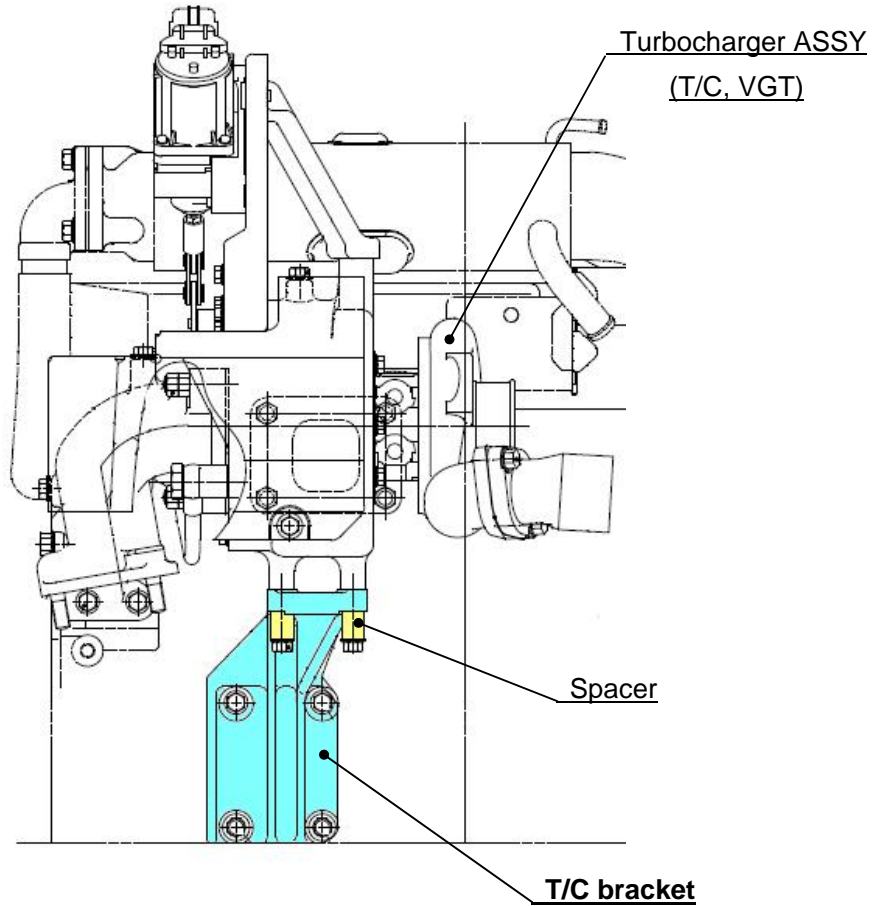
Replace VGT Bracket to countermeasure one in order to prevent the crack of turbine housing.

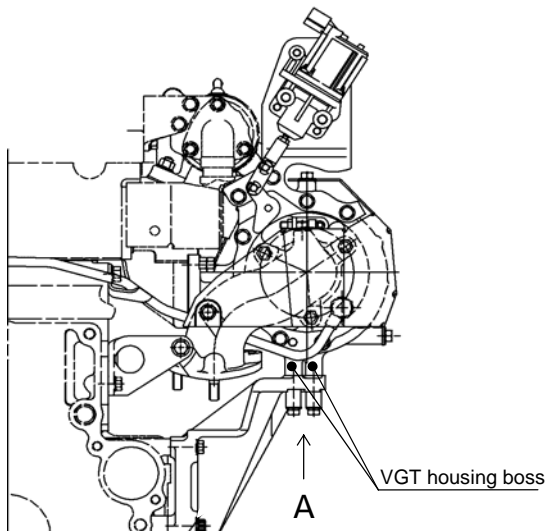
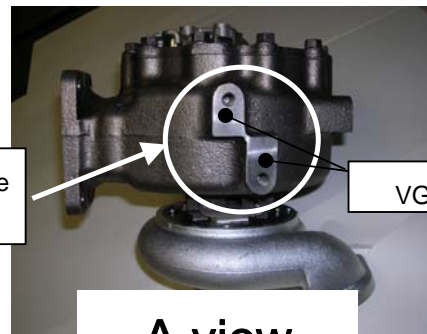
Conduct a penetrant inspection to confirm existence of crack occurrence around VGT housing boss. If a crack is found, replace VGT with a new one. → Jump to chapter "4".

Confirm existence of crack occurrence around VGT housing (See white

VGT Housing
