L-Line Cargo > 360
A-Line Acterra
Service Bulletin

Sterling Service Bulletin, July 2006 Page 1

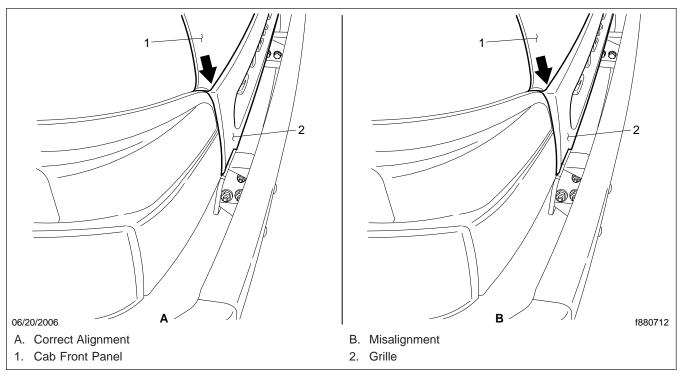
Fig. 1, Grille Alignment/Misalignment

The five clips used to fasten the upper portion of the grille to the cab may not hold with enough force to prevent the grille from loosening under certain conditions. In such cases, inspect the grille for signs of misalignment, and, if found, replace the five clips with new bird-cage clips, p/n 23–12848–000 (available at the PDCs).

Inspect the upper edge of the grille where it meets the inboard end of the headlight lens. The grille should align closely with the lower edge of the cab front panel. If the outboard ends of the grille protrude forward as shown in **Fig. 1**, remove the grille and replace the five clips on the upper edge.

- 1. Set the parking brake and chock the front tires.
- 2. Remove the grille from the cab.
- 3. Remove and discard the five clips along the upper edge of the grille. See Fig. 2.
- 4. Cut off the vertical portion from each end of the foam surround as shown in Fig. 3.
- 5. Install five new bird-cage clips, p/n 23-12848-000, on the upper edge of the grille.
- 6. Install the grille on the cab.
- 7. Remove the chocks from the front tires.
