CAMPAIGN BULLETIN

Subject: **Campaign 07C-1**
Sterling 360 EGR Cooler

360 – EGR Cooler Recall

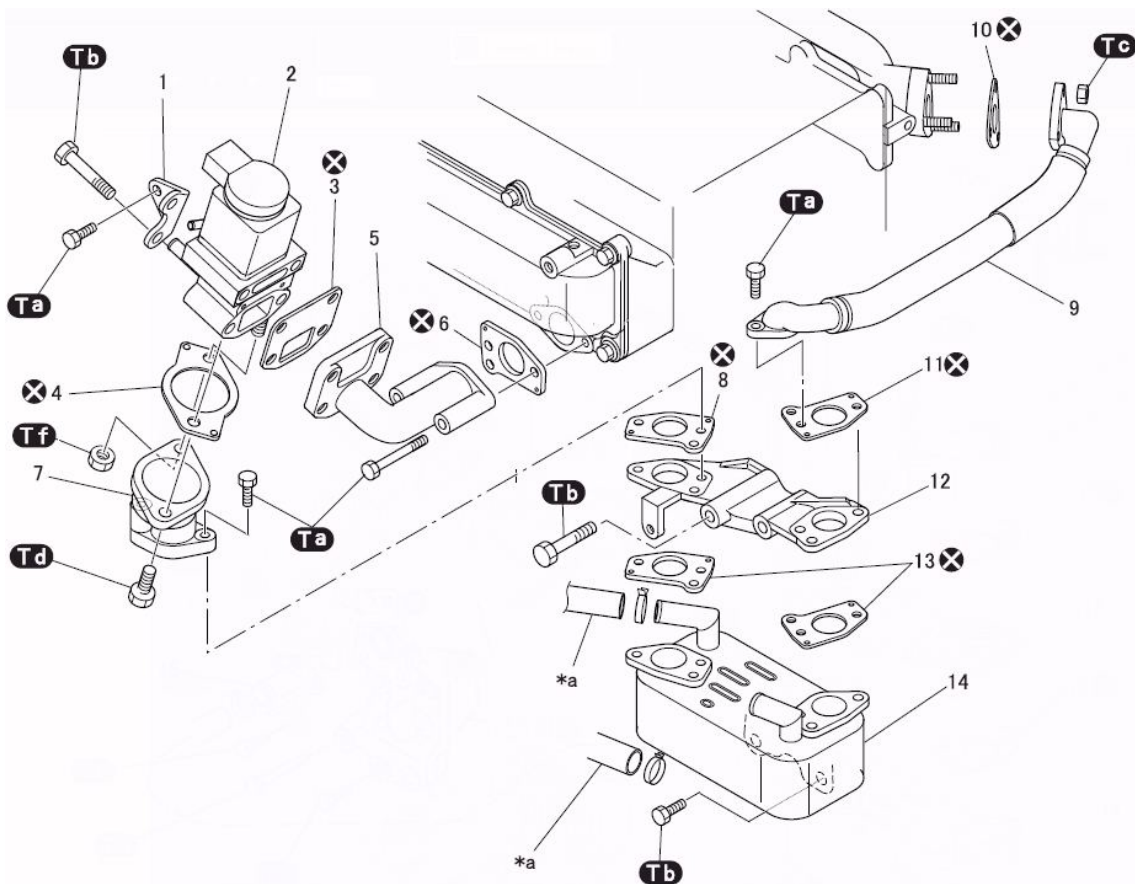
- a. Remove EGR valve as a complete assembly (Fig 1, callouts 2, 5, 7).
- b. Remove EGR pipe (Fig 1, callout 9).
- c. Remove hoses from EGR cooler.
- d. Remove EGR cooler bottom mounting bolts.
- e. Remove EGR cooler bracket B (Fig 1, callout 12).
- f. Install new cooler (kit item E) in reverse order using new gaskets (kit items A,B), bolts (kit items G, H), and nuts (kit item F). Fig 1, callouts 3 and 4 (kit items C, D) are not needed since the EGR valve was removed as an assembly.
- g. Tighten all bolts/nuts finger tight until the cooler, brackets, EGR assembly, and pipe are in place to ensure that all mating surfaces are properly aligned. Snug up all bolts. Finally torque all fasteners.

Callout	Item	Torque
1	EGR bracket	-
2	EGR valve	-
3	EGR valve gasket B (kit item C)	-
4	EGR valve gasket A (kit item D)	-
5	EGR cooler adapter B	-
6	EGR gasket (kit item B)	-
7	EGR cooler adapter A	-
8	EGR gasket (kit item B)	-
9	EGR pipe	-
10	EGR pipe gasket (kit item A)	-
11	EGR gasket (kit item B)	-
12	EGR cooler bracket B	-
13	EGR gasket (kit item B)	-
14	EGR cooler (kit item E)	-
*a	Water hose	-
⊗	Non-reusable	-
Ta	Torque to	17 ft.lbs
Tb	Torque to	33 ft.lbs
Tc	Torque to	15 ft.lbs
Td	Torque to	42 ft.lbs
Tf	Torque to	42 ft.lbs

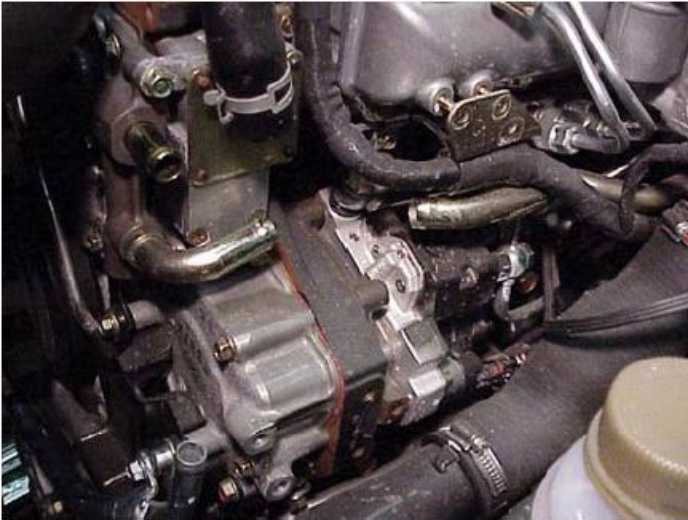
Photo 1

- a. At engine left hand side remove existing hose (Photo 1) and install new joint (kit item I), hoses (kit item J and K), and new clips (kit item P qty 6)(Photo 2).

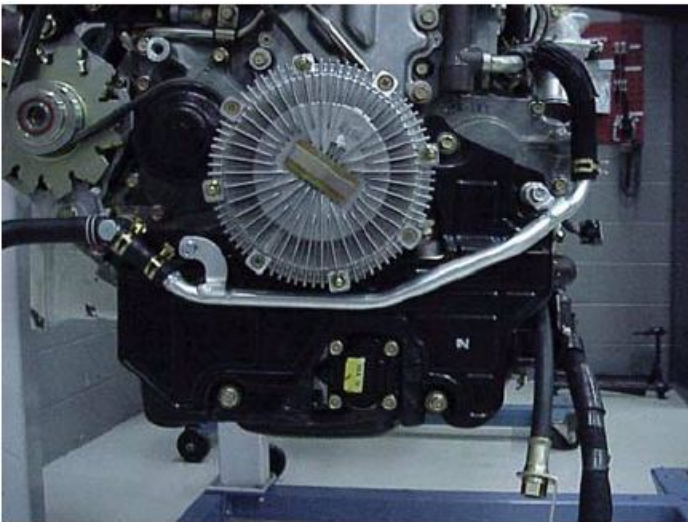
Photo 3

- b. At engine right hand side remove existing hose between engine front cover to heater plumbing and mounting clamp (Photo 3). Save clamp.
- c. Make up joint/hose/clip/clamp assembly (kit items M, N, O, P qty 2, Q qty 2, T, R qty 2)(Photo 4). Reuse mounting clamp from step 4b.

- d. Install assembly to engine and heater pipe. Align like shown in Photo 3, taking care to position clips/clamps away from fan.
- e. Remove two front cover bolts, install new water pipe (kit item L)(photo 3) with clips to new hoses in step 4a and 4c, and then mount the pipe to the engine cover with new bolts (kit item S qty 2). Position the new clips/clamps away from fan. Tighten threaded clamps as shown in Fig 2. Rotate the fan by hand and visually inspect for adequate clearance.

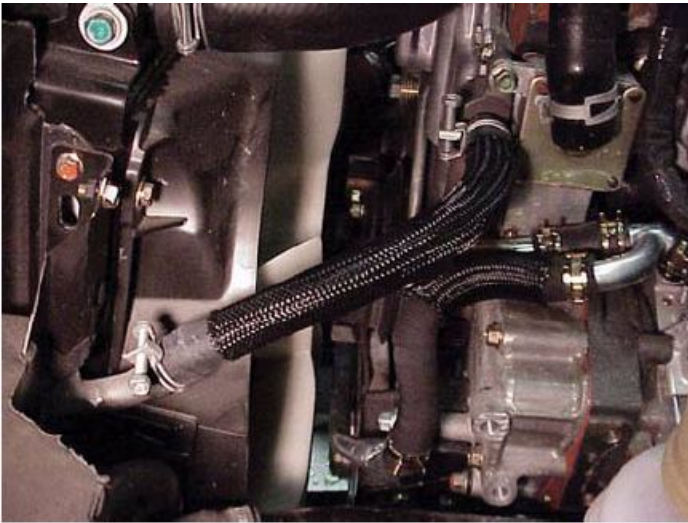
Photo 5

- f. Engine left hand side remove the existing engine to heater pipe hose and install new hose (kit item U) with clamps (kit item R qty 2)(photo 5). Tighten threaded clamps as shown in Fig 2.
