CAMPAIGN BULLETIN

Subject: **Safety Recall 08C4**
Sterling 360 Turbocharger Bracket

Safety Recall Bulletin 08C4

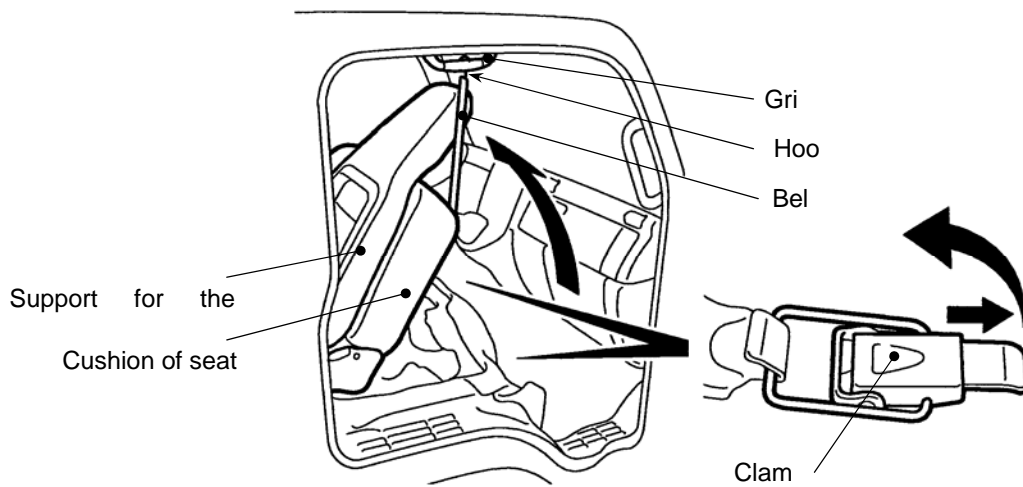
4.2.1.b.1. Open the inspection lid under the passenger seat

- 1) Tip the seatback forward
- 2) Fold back the floor mat and release the two clamps.
- 3) Raise the seat cushion and attach the hook to the grip.

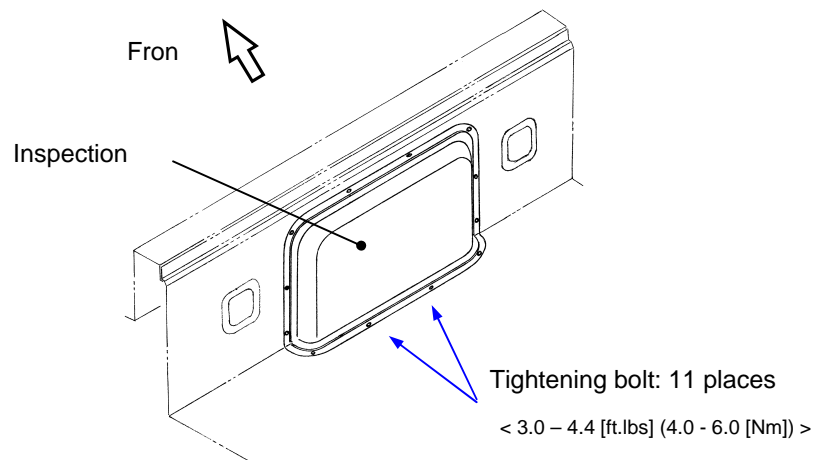
4.2.1.b.2 Open the inspection lid in front of rear seat

- 1) Remove scuff plates on both LH and RH at rear seat.
Note Don't break a clip MC907695 because the clip is reusable.
- 2) Pull a floor mat off floor in order to make an inspection lid available.
- 3) Loosen fixing bolts for inspection lid and open the lid.

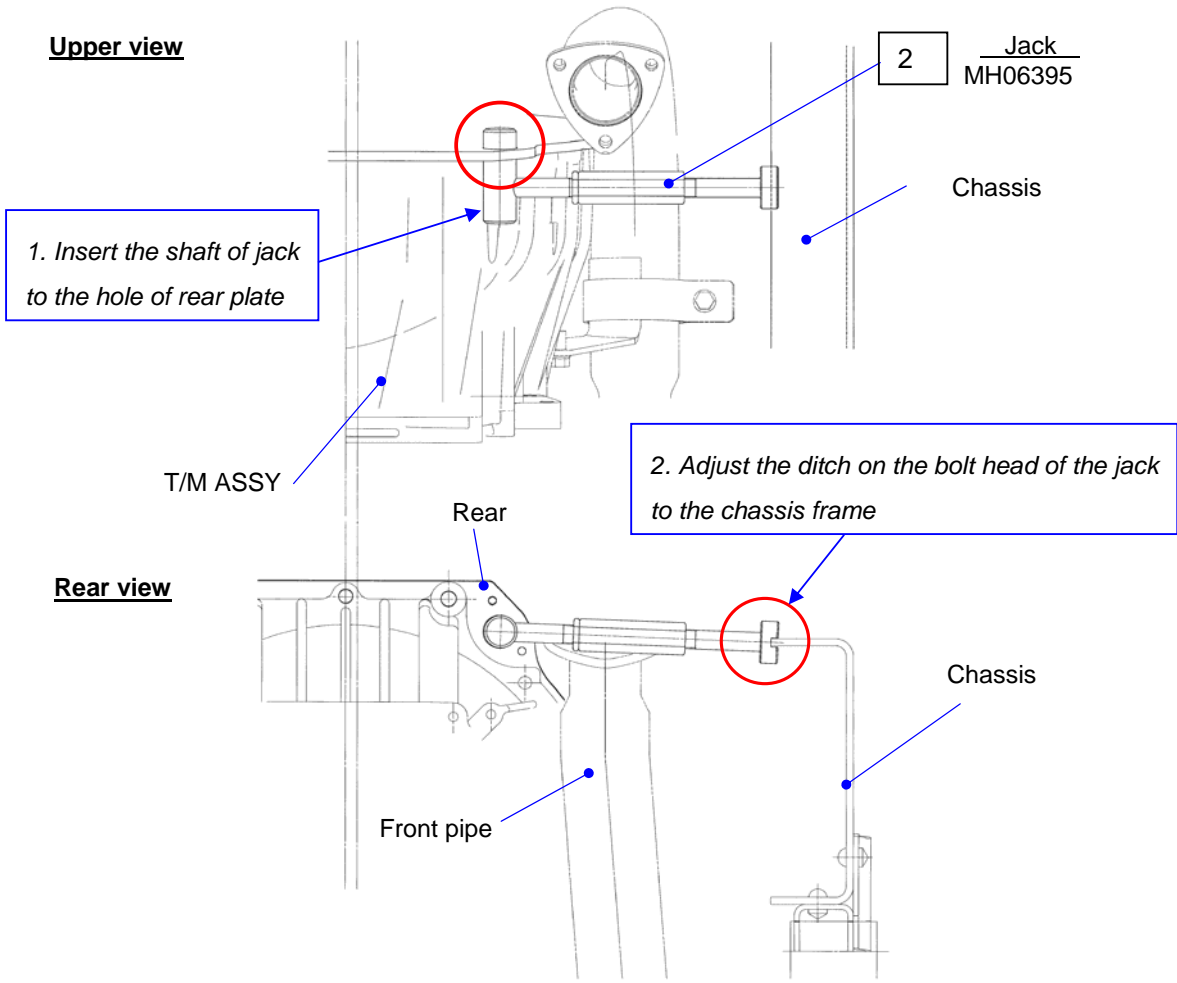
Right side view

If it is difficult to remove the T/C, use the Jack<MH063952> in order to expand the space between engine and chassis frame

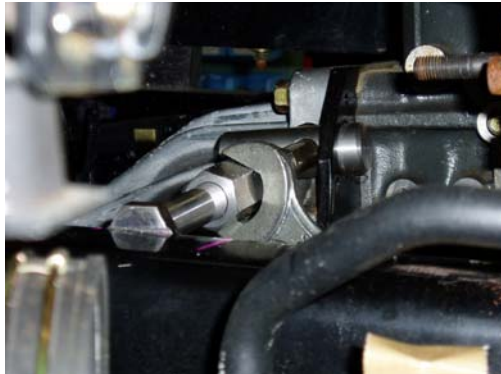
3. Rotate the turnbuckle of jack to the direction of the arrow with a spanner
